Manhole Inspection Summary

Manhole # S21O__003MH

Location Address: **650 S PAYSON-BRICE-ALLEY** Cross Street: **EAGLE-OHIO-ALLEY**

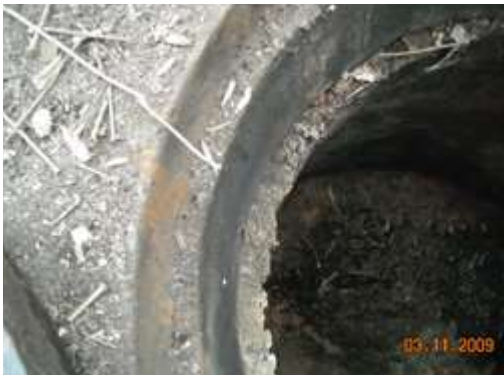
Defect 1

Frame Offset: **1** (in.) Condition: ☒ Sound ☐ Cracked ☐ Leaks

FRAME OFFSET

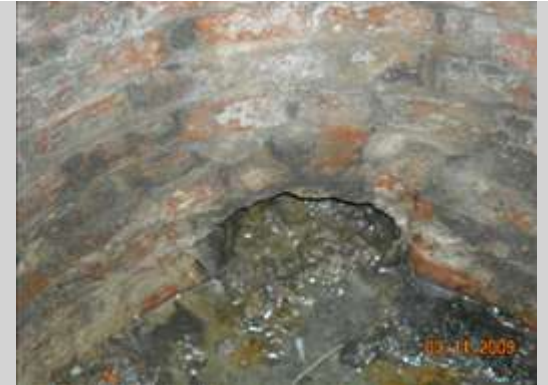
12 O'Clock Outflow

8 in. Circular Gravity Sewer
Pipe Out @ 12 O'Clock

Deposits: ☐ None ☐ Mud ☒ **Sludge** ☐ Debris ☐ Grease

Silt Depth: **1** (in.) Deposits Extent: **Light**
